Samsung Galaxy Tab A Earphone Jack Replacement

This guide will show you how to access and replace the earphone jack.

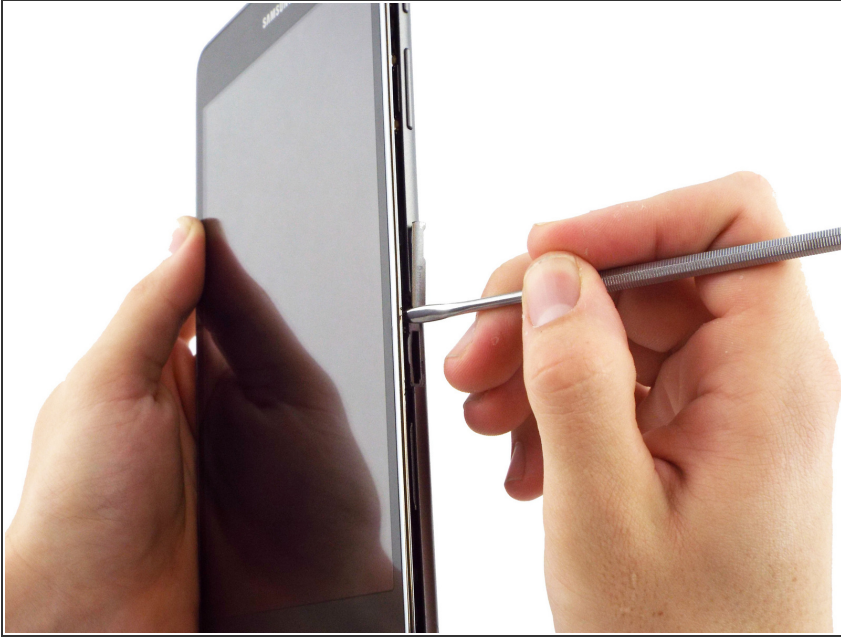
Step 1 — Earphone Jack

- At the top portion of the memory card slot, use the small metal spudger to create separation between the back cover and the rest of the device.
-

The small metal spudger is only used to create separation between the back cover and the rest of the device, not to remove the back cover.

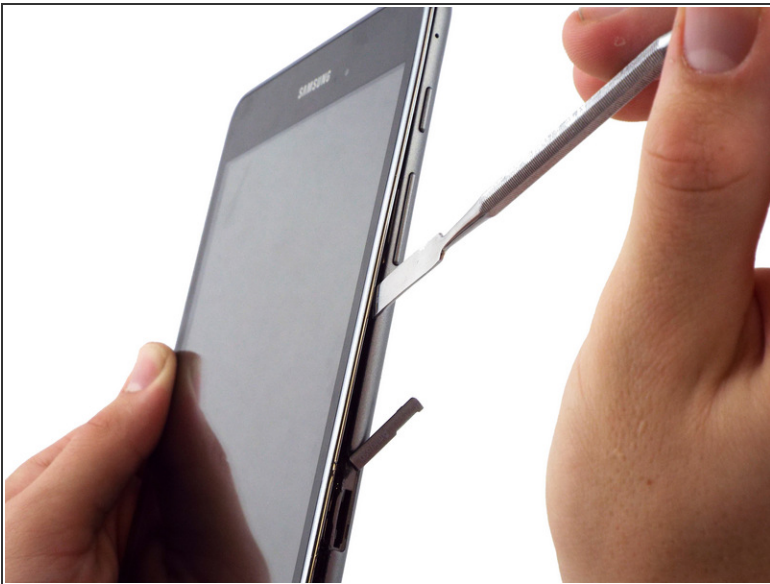
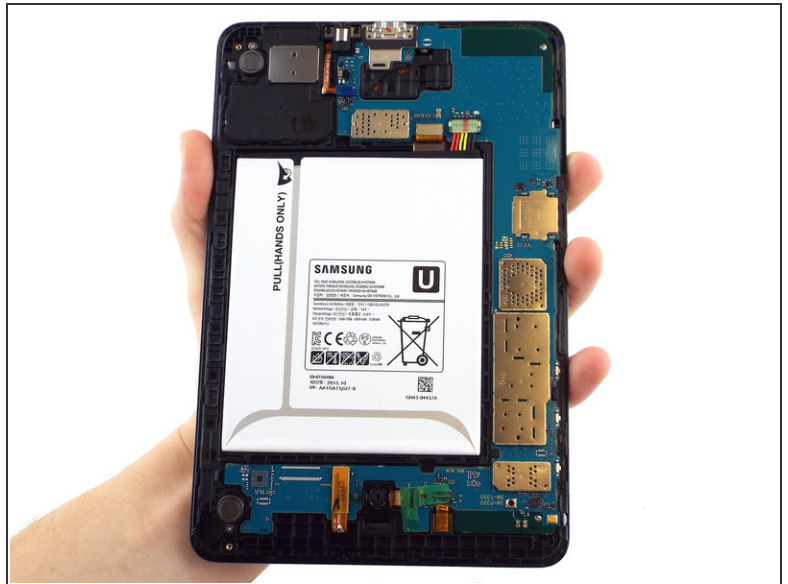
Step 2

- Use the intermediate metal spudger in place of the small metal spudger to remove the back cover. This is done by sliding the intermediate metal spudger around the perimeter of the device, beginning at the top portion of the memory card slot.
- The second picture shows the internal portion of the device once the back cover is removed.

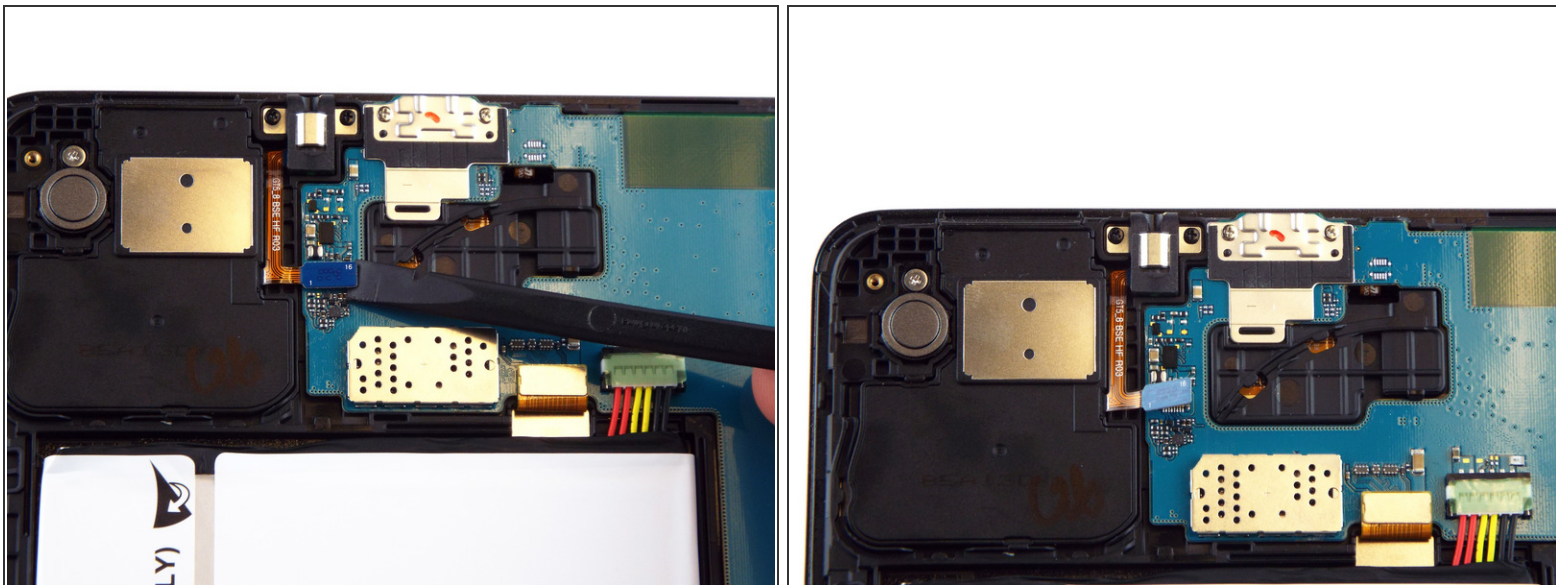
Step 3

- Use the spudger to disconnect the earphone jack from the motherboard.
- ⓘ To prevent any damage to either the earphone jack or motherboard, it is recommended to remove the jack at its blue rubber portion.
- The connected and disconnected earphone jack is shown in the first and second picture, respectively.

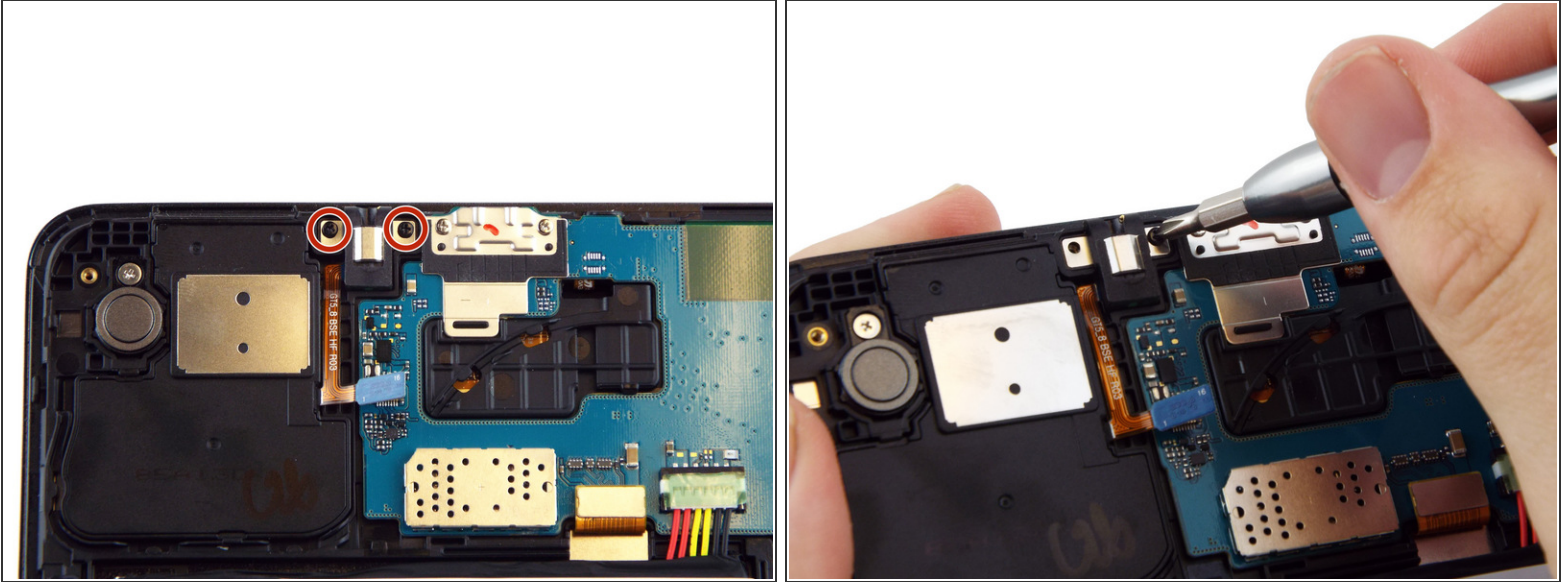
Step 4

- Use the PH0 screwdriver bit to remove the 2.5 mm screws attaching earphone jack to the rest of the device.
- The second picture shows this process in action.

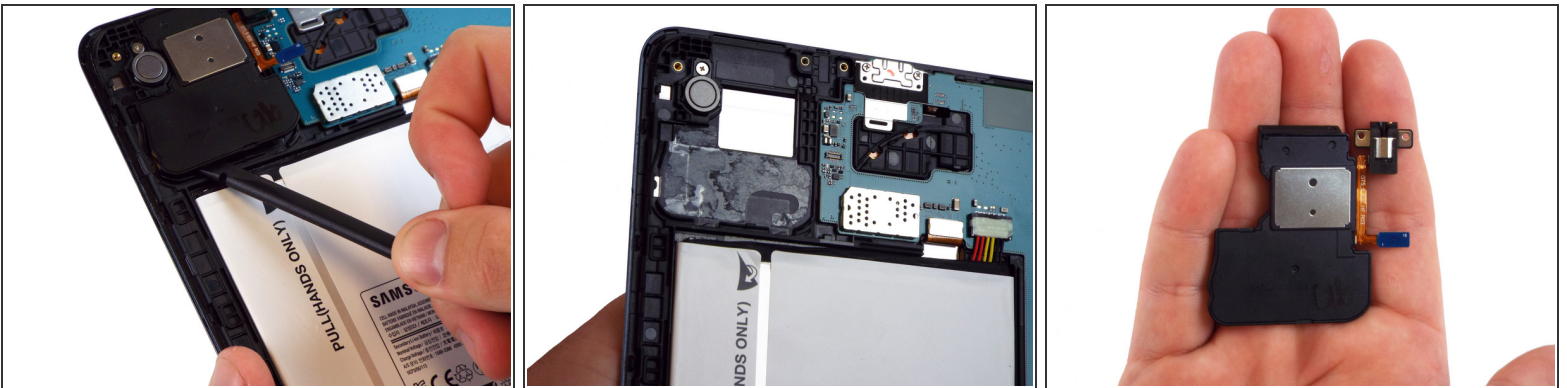
Step 5

- Use the spudger to fully remove the earphone jack from the rest of the device.
- The second picture shows what the device should look like once the earphone jack has been removed.
